KIRK STREET AGENTS' HOUSE

Lowell National Historical Park

Historic Structure Report

Written 1990 - Published 1997

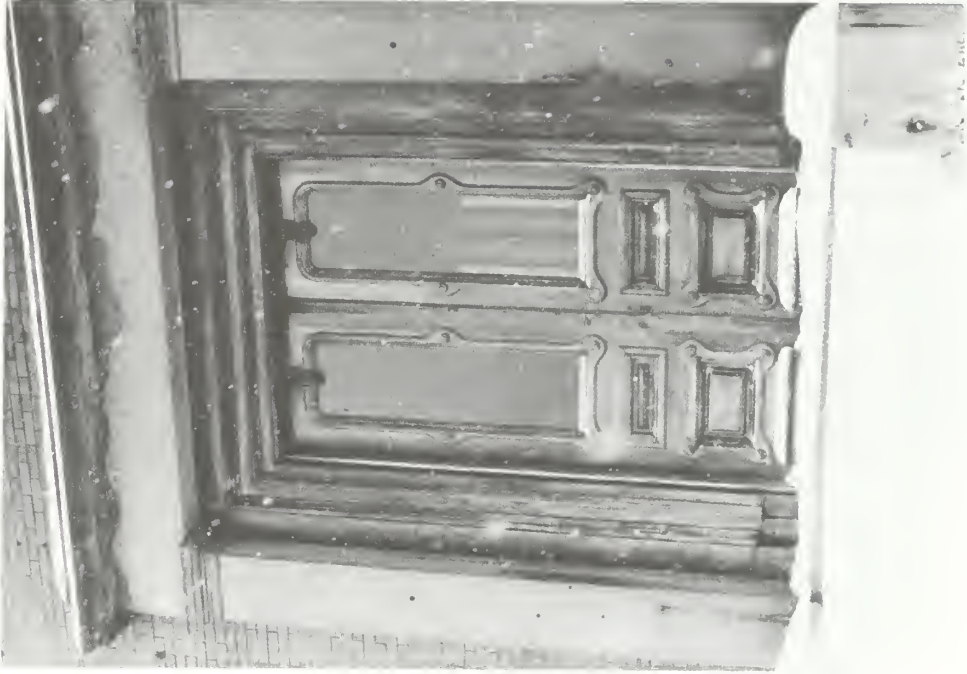
Figure 50. Main Block, West Elevation: North-Unit Entrance.

North-Unit Entrance. The wooden trim around the north unit's doorway opening (D101) dates to the 1870's. This trim (fig. 50) differs from that of the south unit. It has no transom or

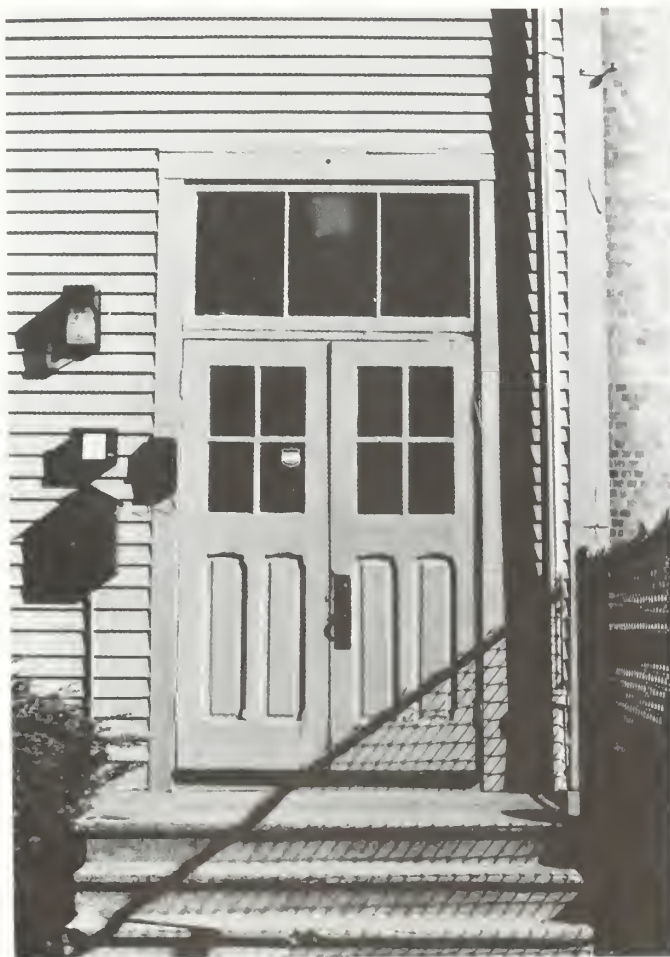
Figure 57. Ell, South Elevation: Entrance Doorway D103.

The wood clapboarding on the south elevation of the south Ell is in good condition. It was painted a cream color in 1981. A modern light fixture, a fire-alarm box, and a mailbox are located at the east end of the south wall to the west of the entrance doorway (fig. 56).

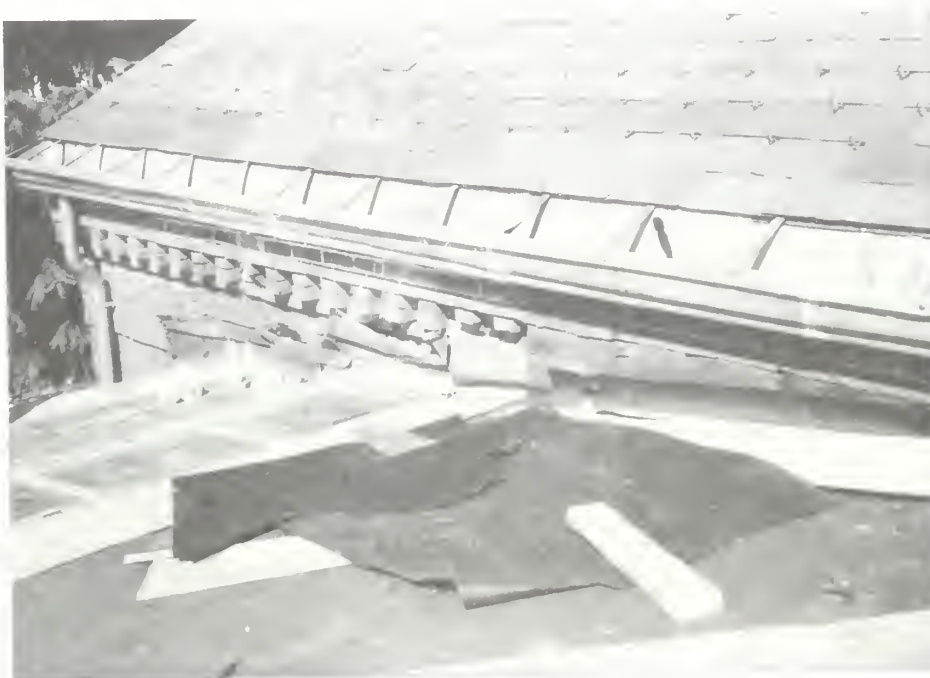
On the ell, the nonhistoric built-up tar and gravel roof was removed. The sheet-metal roof underneath was first recorded and then replaced with sheet-metal roofing of flat-seam, pan construction and flashing to match the former sheet-metal roof (fig. 65). The built-in wood gutters were connected to downspouts at the southeast, southwest, and northeast ends of the eaves. The roof was then painted.

Figure 65. South-Unit Stair Tower: Roof at Junction with Main Block.

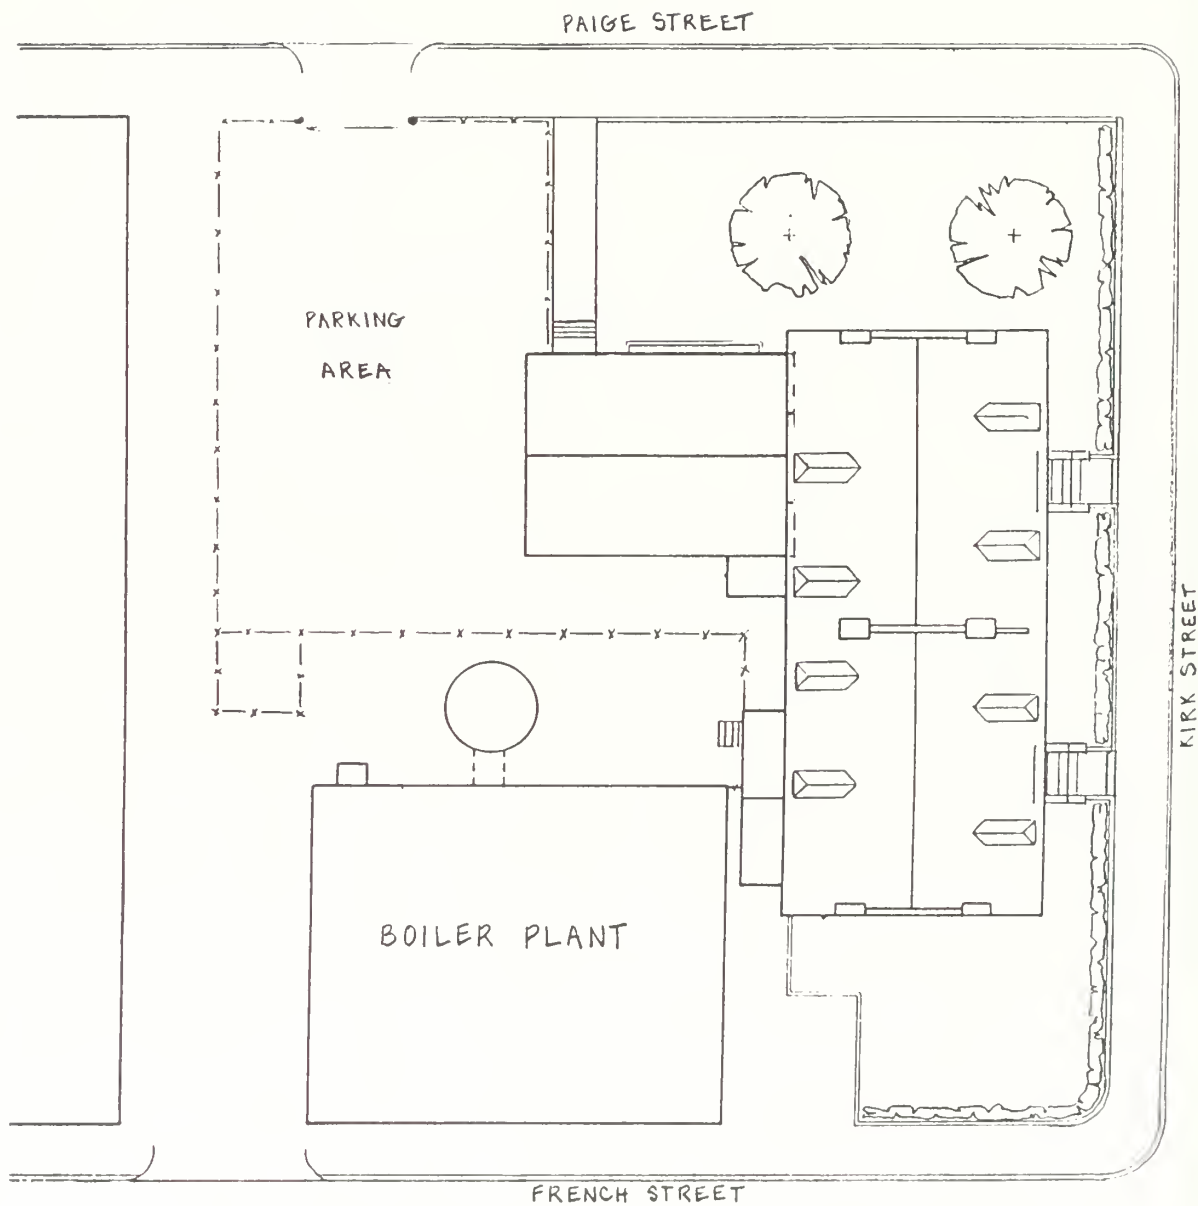
KIRK STREET AGENTS' HOUSE
SITE PLAN

A masonry curb runs along the west, Kirk Street side of the Agents' House property (see figure 66). Most of the curb—from the south boundary to a point 30 feet north of the north unit's entrance walkway—consists of the original beveled granite curb. North of this curb is a 10-foot-long section of replacement granite curbing. The remaining curb consists of modern poured concrete that extends around the corner onto the north boundary.

The black chain-link fence that runs along the east section of the south boundary continues halfway across the east side of the property, enclosing a modern parking area. It then turns west, approaches the rear wall of the main block, then runs north to intersect the north unit's stair tower (see figure 66).

Figure 66 shows the present configuration of the Agents' House site. The large 1922 boiler plant is situated where the north unit's ell and its attached shed were formerly located. The shed formerly attached to the rear of the south unit's ell has been removed; the site is now occupied by an asphalt-paved parking lot. Two other buildings are situated behind (to the east of) the Agents' House. On Paige Street is the Clement McDonough Arts Magnet School, built as the Manual Training School circa 1901 on the former site of the Boott stables. On French Street is the 1939 Lowell Trade School, which occupies the former site of the Boott Overseer's Block.

Figure 66. Site Plan of Kirk Street Agents' House.

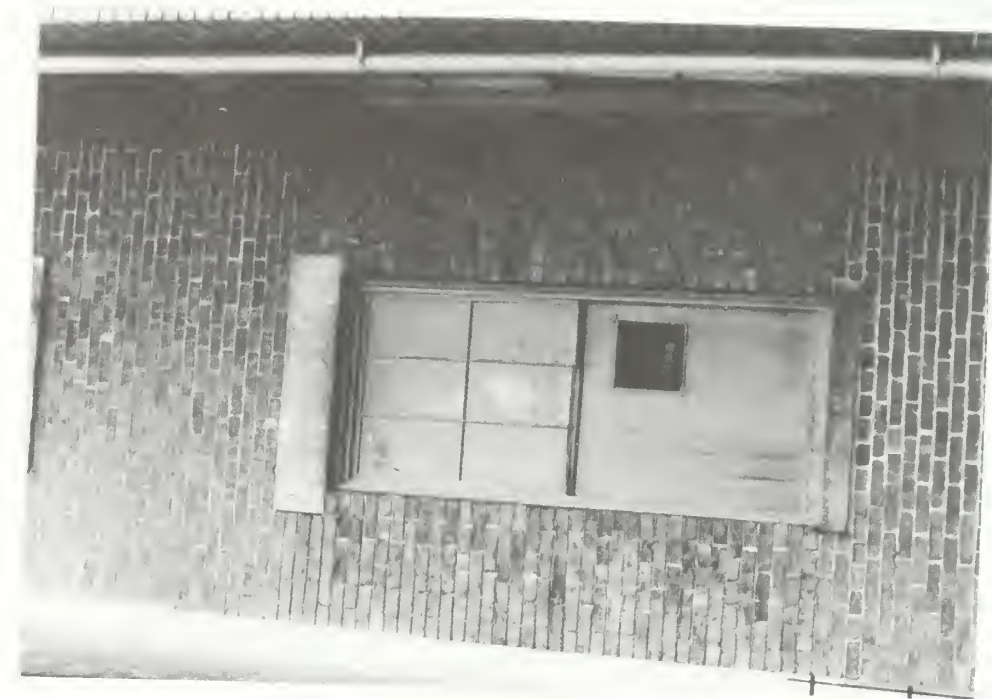
Figure 74. North-Unit Stair Tower, North
Elevation: Window W124.

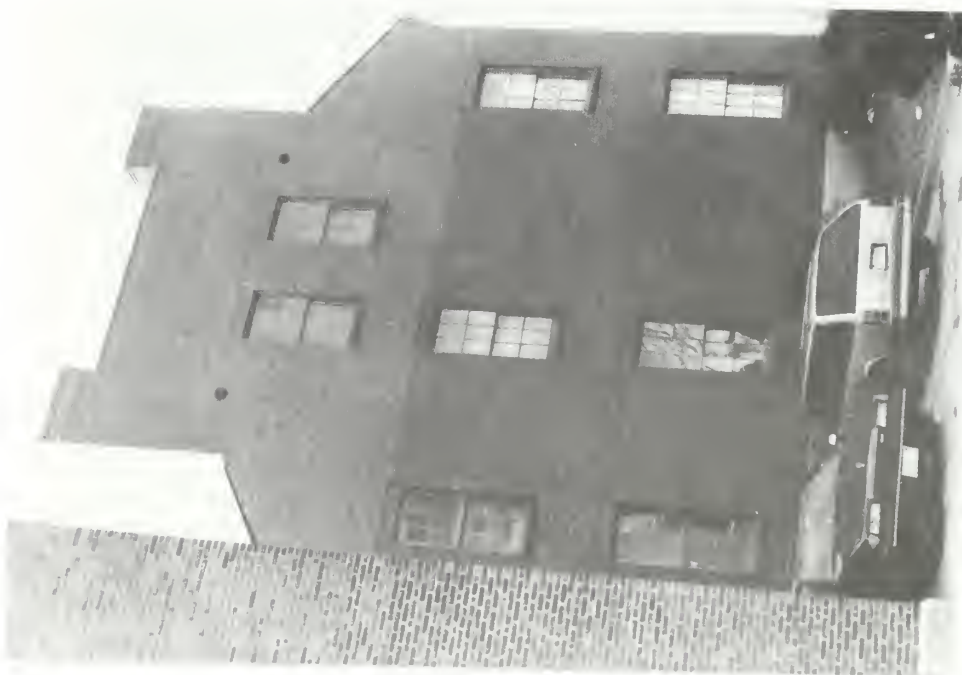
The north brick wall of the main block is in good condition (fig. 73). Some areas show signs of having been repointed. Other areas are in need of repointing, but the mortar loss does not seem to be severe.

Figure 73. Main Block: North (Side-Street)
Elevation.

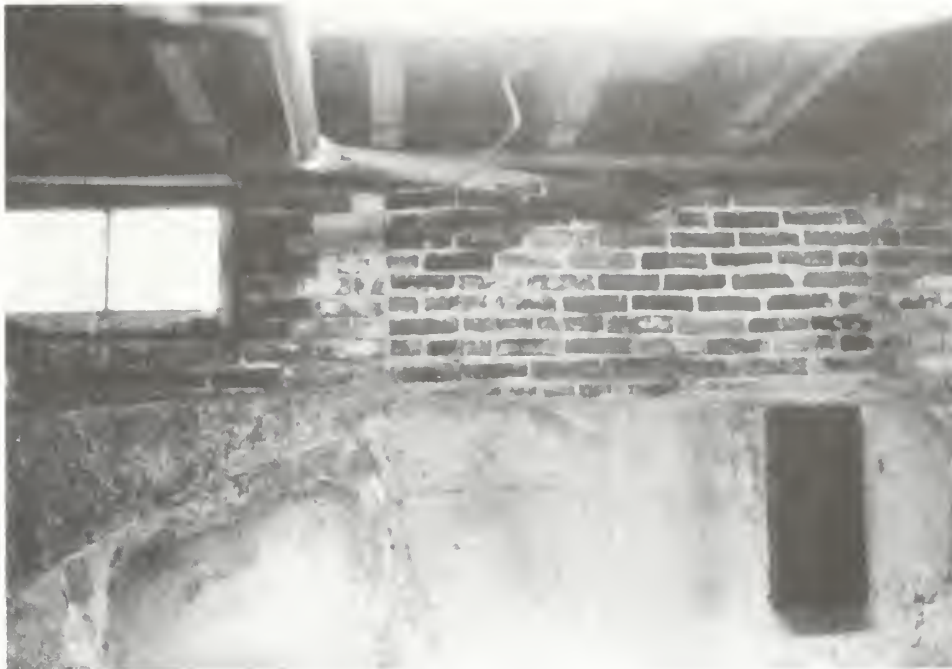
Figure 88. Room E001 (Ell Cellar), East Wall: Blocked 1847 Bulkhead Opening.

Doorways. There are currently no doorways in the ell cellar. The remnants of two former doorway-type openings can be seen in the walls of the ell. One is a bricked-up opening in the north wall, east of W009 (fig. 33); see Chapter III for further discussion of this feature. The other former doorway is thought to have been an original bulkhead (fig. 88); it is now blocked with concrete blocks and bricks.

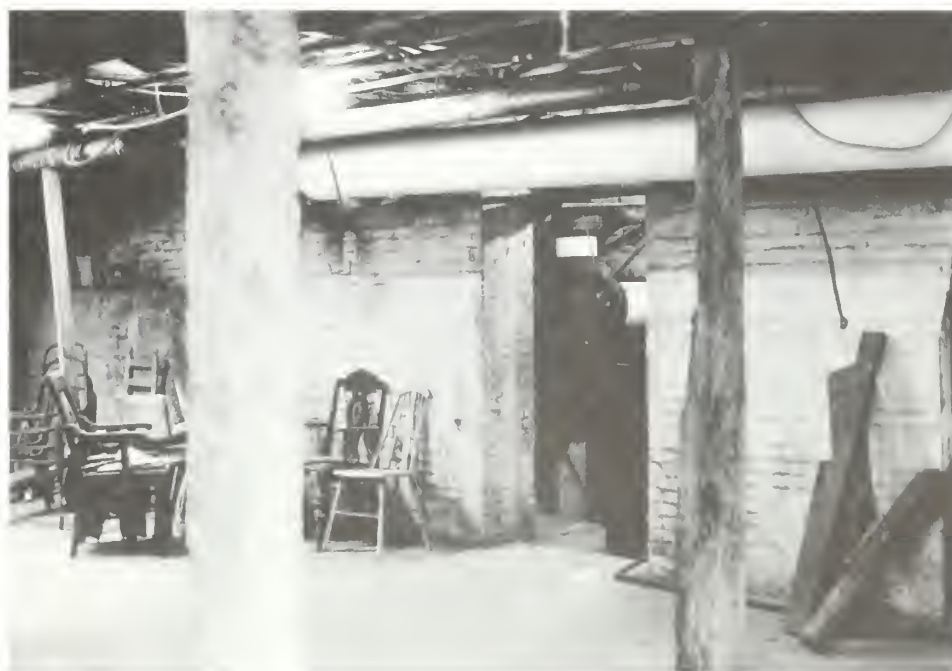
Figure 89. Room N001 (Main-Block Cellar of North Unit), Looking East.

Doorways. A large doorway in the east wall of the cellar (see figure 89) leads to the adjacent stair-tower cellar. This is an original doorway that was enlarged circa 1922.

Heating and Plumbing Equipment. Large heating pipes run through a hole in the east foundation wall and across the room at ceiling level (see figure 89). They pass through a hole in the south, party wall to reach the south unit's main-block cellar.

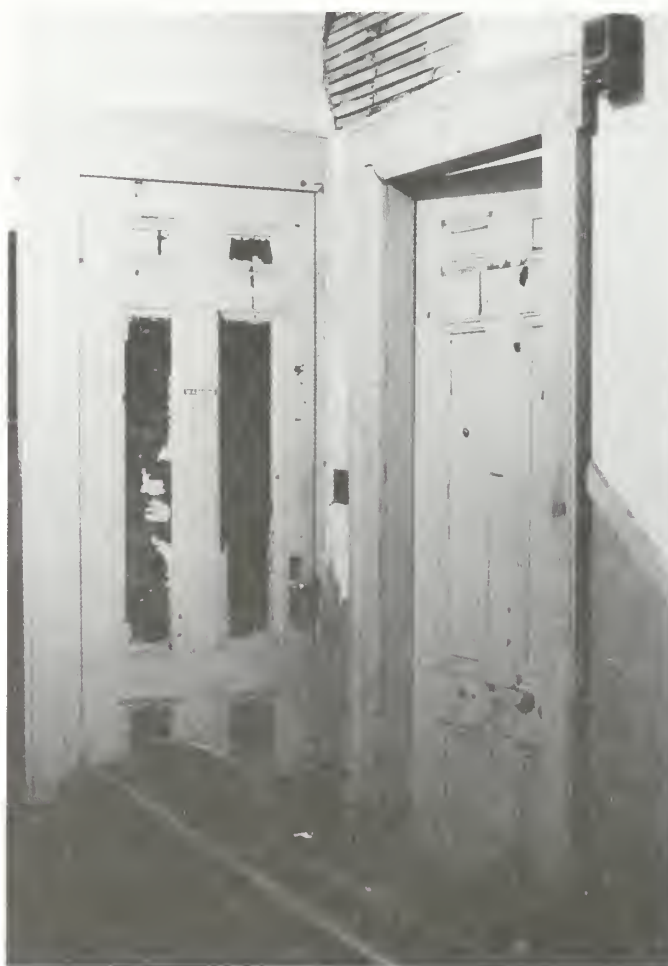
Figure 94. Room S202 (South-Unit Stair Hall), East End.

Walls. Original lath and plaster appear to be extant on the east wall and on the south stair wall. Some of this is failing, exposing the 1847 lath (fig. 94). Ca.-1922 plaster is found on most of the north wall. The west ends of the north and south walls (west of D209 and D210) consist of ca.-1945 plasterboard. A section of 1/8-inch plywood covers a 4- by 4 1/2-foot section of the south wall just west of D210.

Doorways. The two doorways in the east half of the stair hall (D211 and D212) are original. They have retained their original Type-J surrounds and six-panel doors. The paint on both doorways is failing (fig. 94).

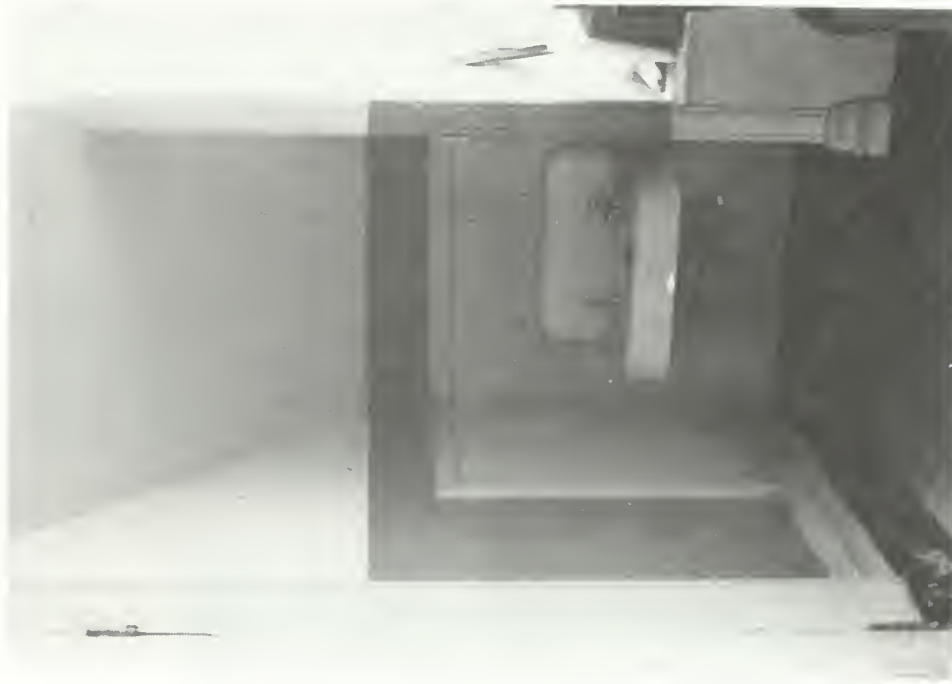
Figure 98. Room N203, East-Bedroom Portion: 20th-Century Sink in Closet under Attic Stairway.

Type-1 wainscot lines the rear portion of the closet in the northeast corner of the room, below the stairway to the attic (fig. 98). This is the same ca.-1922 wainscot as used in the ell's stair halls (E103 and E202) and the south unit's stair tower (S105).

Wall-mounted sinks from the 1930's are located in the closet under the attic stairway (fig. 98) and at the extreme east end of the north wall. The large cast-iron pipe below window W227 appears to be a sewer pipe, perhaps related to these two sinks.

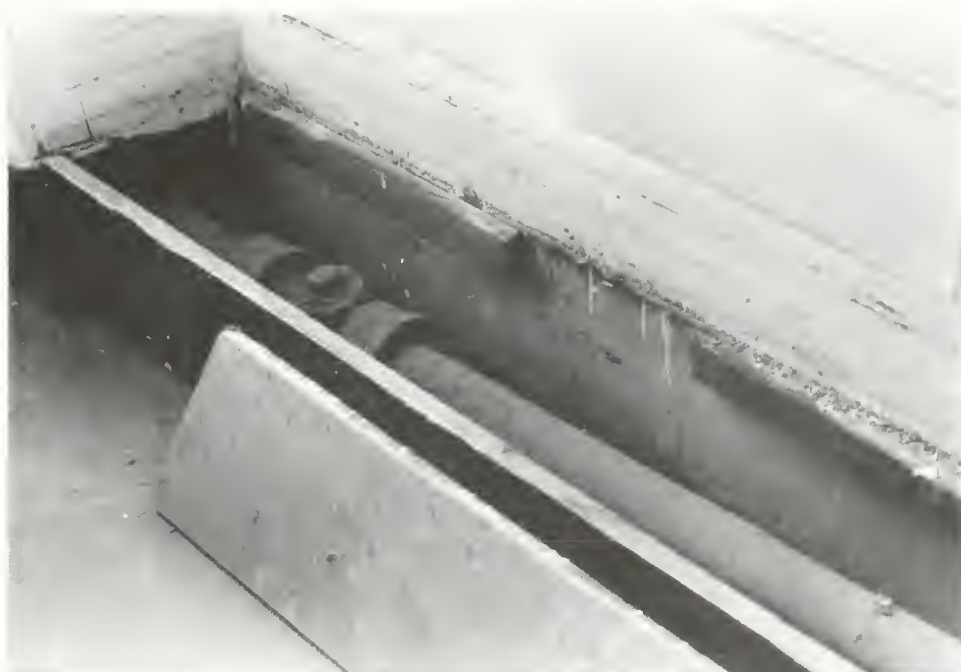
Figure 99. Room N203 (East and West Bedrooms in North Unit), East Wall:
Box under W227 Concealing Waste Pipe.

The two original window openings in the east wall (W226 and W227) have retained most of their 1847 elements in fair condition. The right bottom panel is missing from both windows' reveals. A box has been built into the recess under W227, through which a large cast-iron pipe runs (fig. 99).

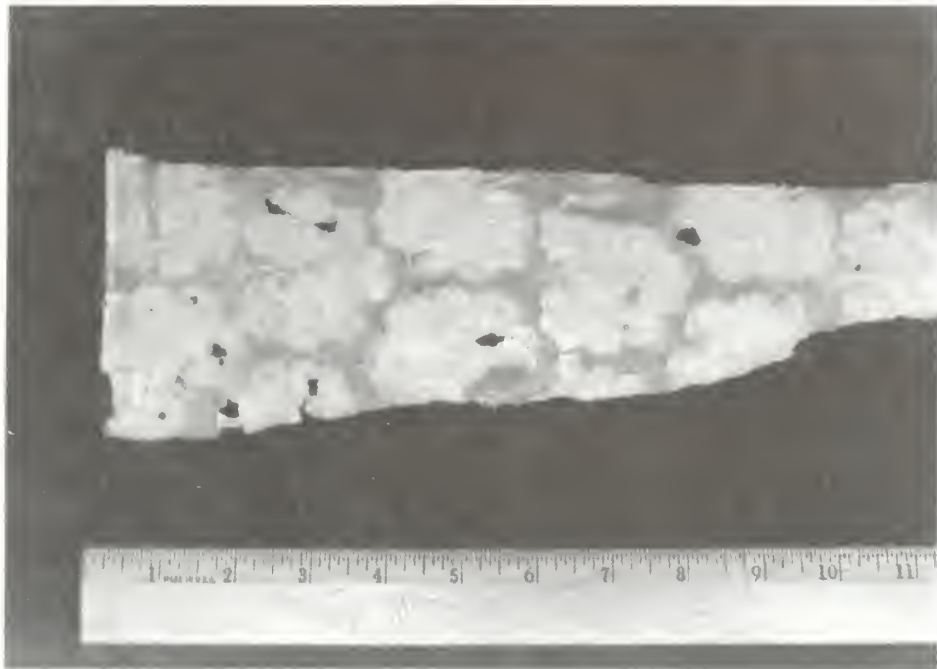
Figure 102. Wallpaper: Layer #1 in Rooms S301, S303, and S305 (circa 1847-1850).

Small fragments of wallpaper with three identifiable layers were found in former bedroom S301. Layer #1 was composed of rag fibers. Its design had a background of green painted around white “shamrocks” 2 inches wide (fig. 102). The wallpaper appeared to have been an early machine-printed paper. The rag-fiber paper, the early machine-printing method, and the relatively small pattern indicates that this paper predates 1855, and may be original to the house.

Layer #1 is the same first “shamrock” layer found in S301 (fig. 102), which has been dated to 1847–1855. Layer #2 is also composed of rag fibers, and has a machine-printed foliate design in blue and green with gold edges on a white ground (fig. 103). This paper has been dated to circa 1855–1865.

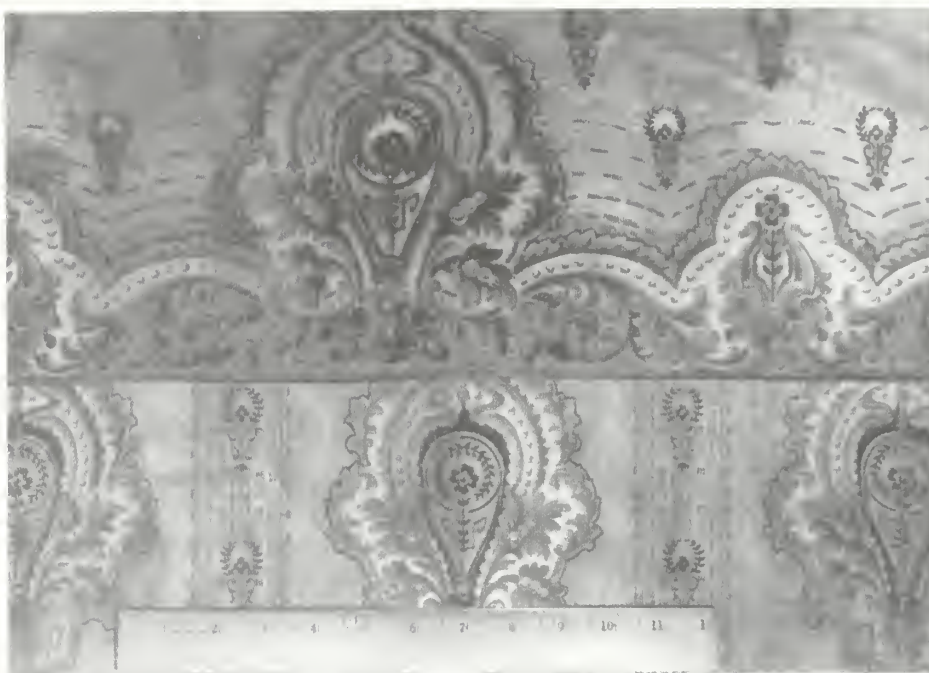
Figure 104. Wallpaper: Layer #4 (Top Layer) in Rooms S303 and S305.

Layer #4 is thought to date to circa 1895–1905. It is a mechanical wood pulp, machine-printed paper with vertical bands of large foliate medallions in burgundy, green, and dark green on a white ground (fig. 104). It was hung in this room with a ceiling paper that had a small white floral pattern on a background of tiny white dots.

Layer #4 is the same top layer found on the walls of the central hall and in Room S303 (fig. 104).

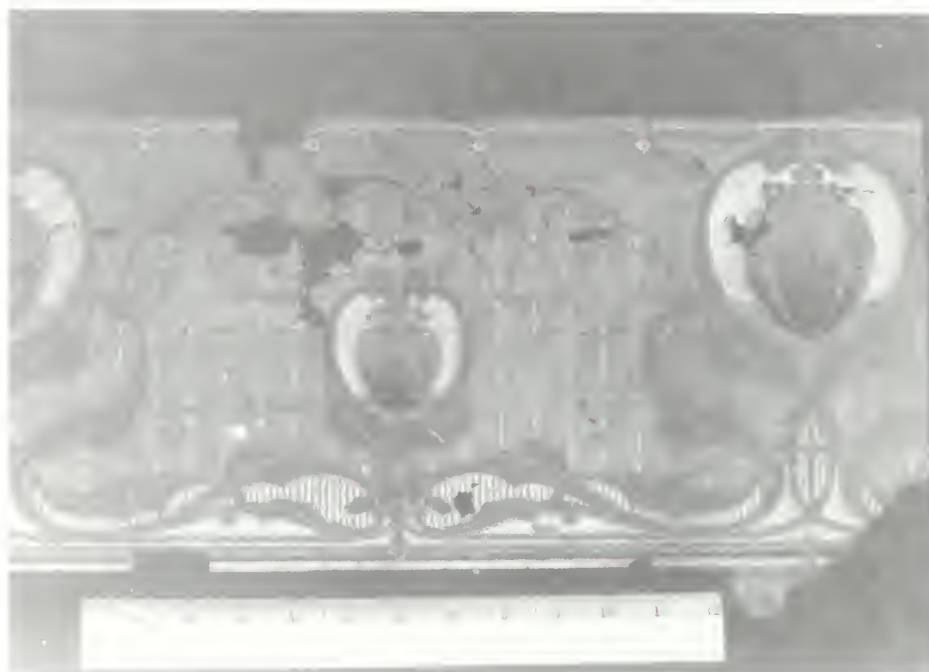
Figure 105. Wallpaper: Layer #4 (Top Layer) in Room S304.

Layer #4 has an Art Nouveau design, machine-printed in brown, black, and sparkling turquoise green on a dark green, diamond-shaped background (fig. 105). This paper is also composed of mechanical wood pulp and has been dated to circa 1895–1900.

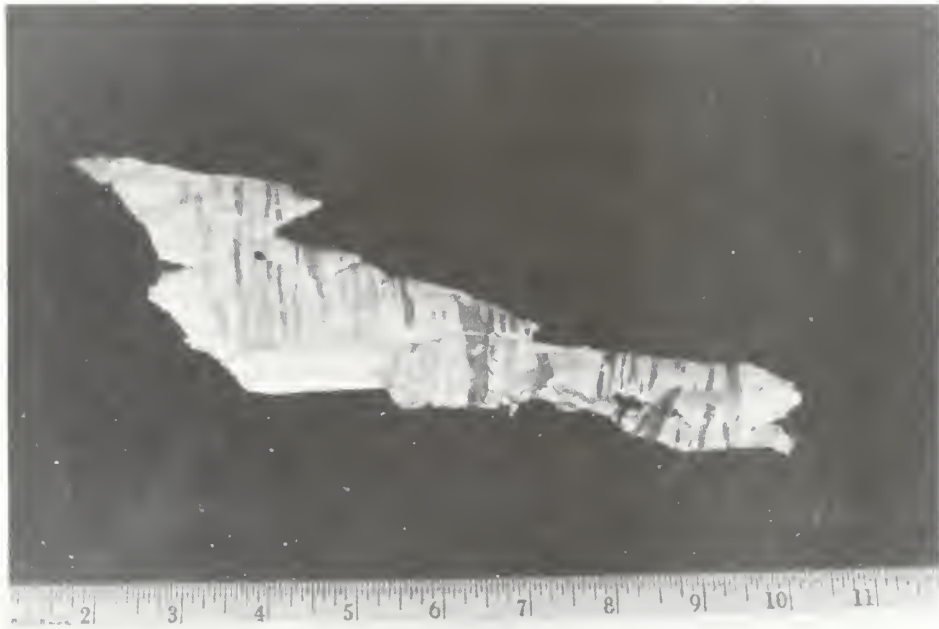
Figure 106. Wallpaper: Layer #1 in Room S306.

This former bedroom has retained six layers, more than the other third-story rooms. Layer #1 is composed of rag fibers, and has an early machine-printed, indeterminate design of dark green and brown on white (fig. 106). This paper may be original to the construction of the Agents' House and has been dated to 1847-1850.
